**Flood Control Project Maintenance  
Levee Inspections**

**Maintenance Issue Types Only, Levee Inspection Report By Mile - Fall 2019**

**Reclamation District No. 0349 Sutter Island**

Waterway	Bank	Unit Miles	Inspection Start/End	Inspector
Unit No. 01 Sacramento River	Right	1.59	10/23/2019 10/23/2019	David Julian

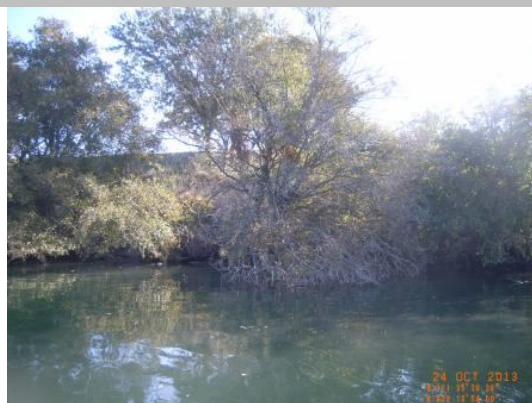
Photo 1 of 1 : FA\_2019\_RD0349\_206\_115\_20190826\_00027.jpg

Comment Code					
Inspector Comment					
2017 Site ID: STR 26.5 L					
Status: Eroding					
2017 Field Notes: There appears soil under geotech fabric that appears to be failing but hard to tell.					
Site History: 2002 - Original rock over geotextile is sliding off and the end is coming unraveled. 2003 - Some minor new erosion on the downstream end. 2004 - Site has gotten worse. Underlined geofabric is exposed. 2005 - Still looks bad with exposed geotextile fabric.					
2006 - Still have some new unraveling and exposed fabric. Site lengthened upstream. 2009 - Minimal new erosion. 2010 - geotextile fabric placed since last year, possible flood fight. 2012 - Exposed geotech style fabric, assume rock on top slid off. 2015 - Erosion pockets covered with plastic.
